1. The requirement for the Landmarks Board to follow the Secretary of the Interiors Standards for Rehabilitation.

2. Five examples of historic properties within the Town of Southampton that have been renovated and have gone through a required review process.

The Local Landmarker

Using Substitute Building Materials at Historic Buildings

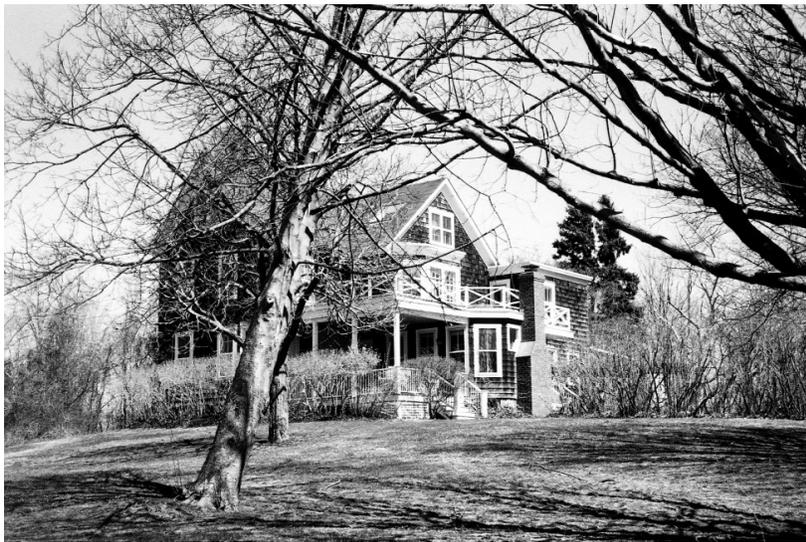
Photo: 1999

This home was built circa 1870 for Captain E. Halsey. It was considered a contributing resource when Sagaponack nominated a historic district to the National Register and to support village incorporation efforts. Circa 2008, with approval from the Sagaponack Village Architectural and Historic Review Board, it was renovated, transforming its traditional farmhouse aesthetic into one with a stripped-down contemporary flair and additions.

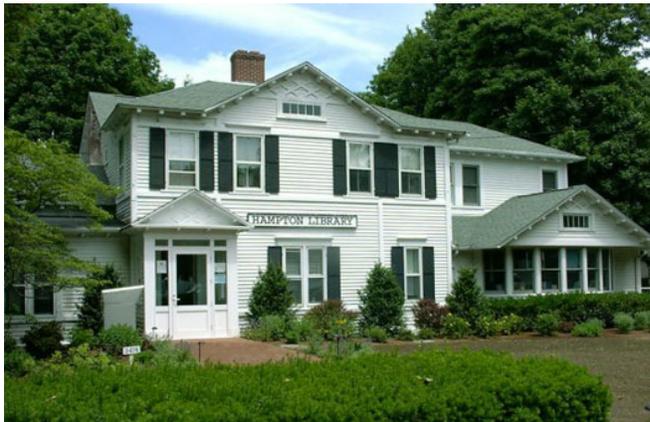
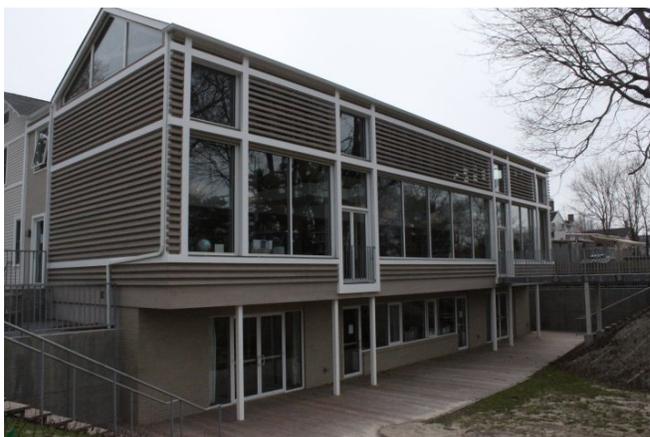
Photos 2010:

The Hampton Library opened in 1895 and was, even then, considerably smaller than as depicted in the vintage post card image below. Nonetheless, its board chose to add on and update its facilities again in 2009. After a \$6 million dollar renovation which included a contemporary addition to the rear of the Queen Anne style building, the library reopened in 2010. It received a review of praise from the Southampton Town Architectural Review Board.

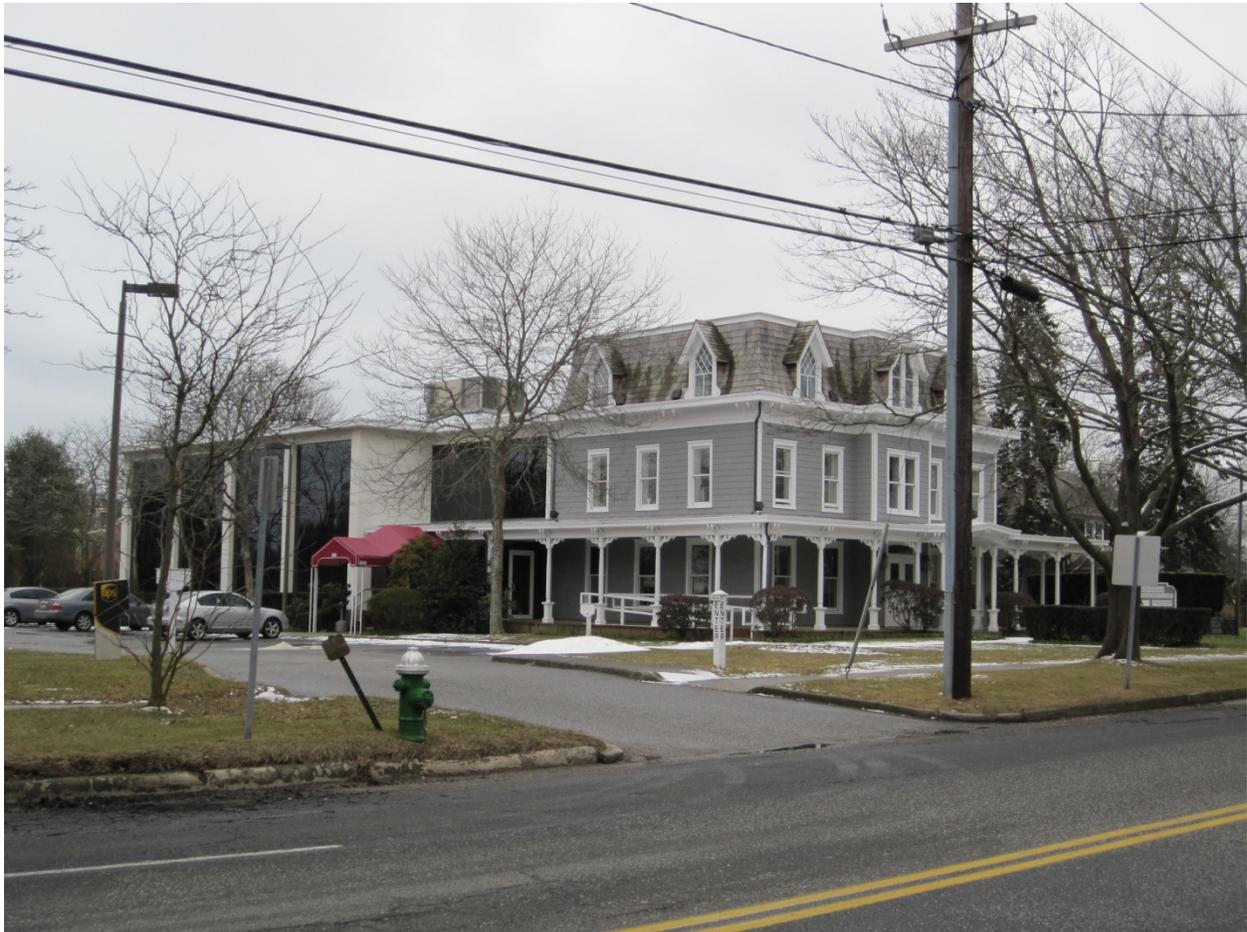
This historic structure was built in the late 1875 by a prosperous ship captain and is one of the best residential examples of the Second Empire style in Southampton Village. “It retains all the salient characteristics of the style including a high mansard roof, prominent dormer windows, decorative bracketing, and a projecting entrance pavilion.”¹ In the 1970s the building received a contemporary addition after being reviewed and approved by the Village’s somewhat newly created Architectural Review Board. (Historic photos are available, but in this it’s obvious where the original building ends and the new addition begins.)

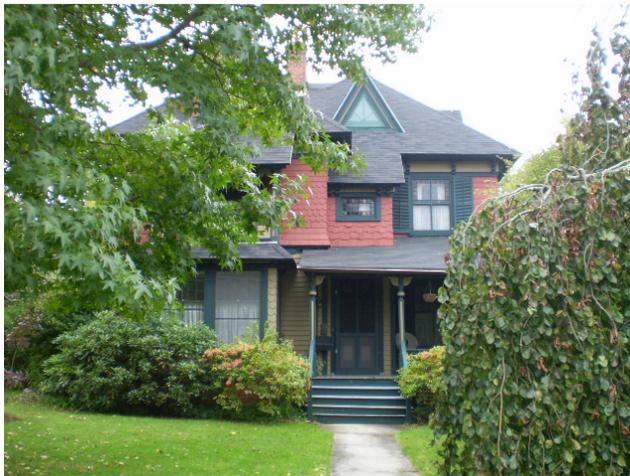
Photo: 2008

Built in 1885 for the widow of the founder of Hildreth's Department Store and her four children, this home is one of the only surviving Stick Style residences in Southampton Village. One of the characteristics of the Stick Style is that the structures were painted vivid colors. Nonetheless, the Southampton Village ARB had no objection.....twice: the first application received permission to strip the home's paint and leave its shingle cladding stained; the second application chose to keep the house a 'painted' structure, but change the color scheme to a lighter palette. The second application also included a substantial addition nearly doubling the size of home and mimicking the original style of architecture.

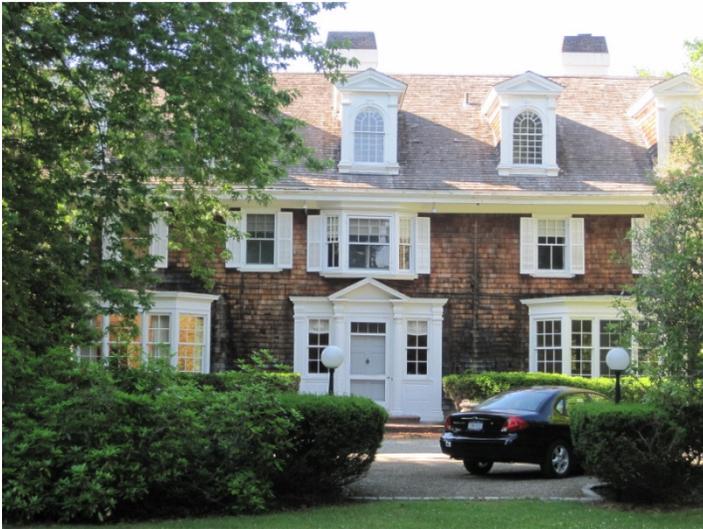
Photo 2010:

This home was designed by F. Burrall Hoffman Jr. (1882-1980), an architect educated at Harvard and the Ecole des Beaux-Arts. It was built circa 1892 for Charles Henry and Lucie C. [Whitney] Lee. "Mr. Lee, whose home in the city was at 24 Gramercy Park, was a grandson of the Gideon Lee who was mayor of New York in 1830 and founded in 1804 the original Lee & Co., which sold out to the United States Leather Company in 1893. Charles H. Lee soon after became head of the Andean Trading Company, and later re-established his own leather business."² In March of 2011, this historic home was approved by the Southampton Village Architectural Review Board to undergo a dramatic renovation and receive substantial additions.

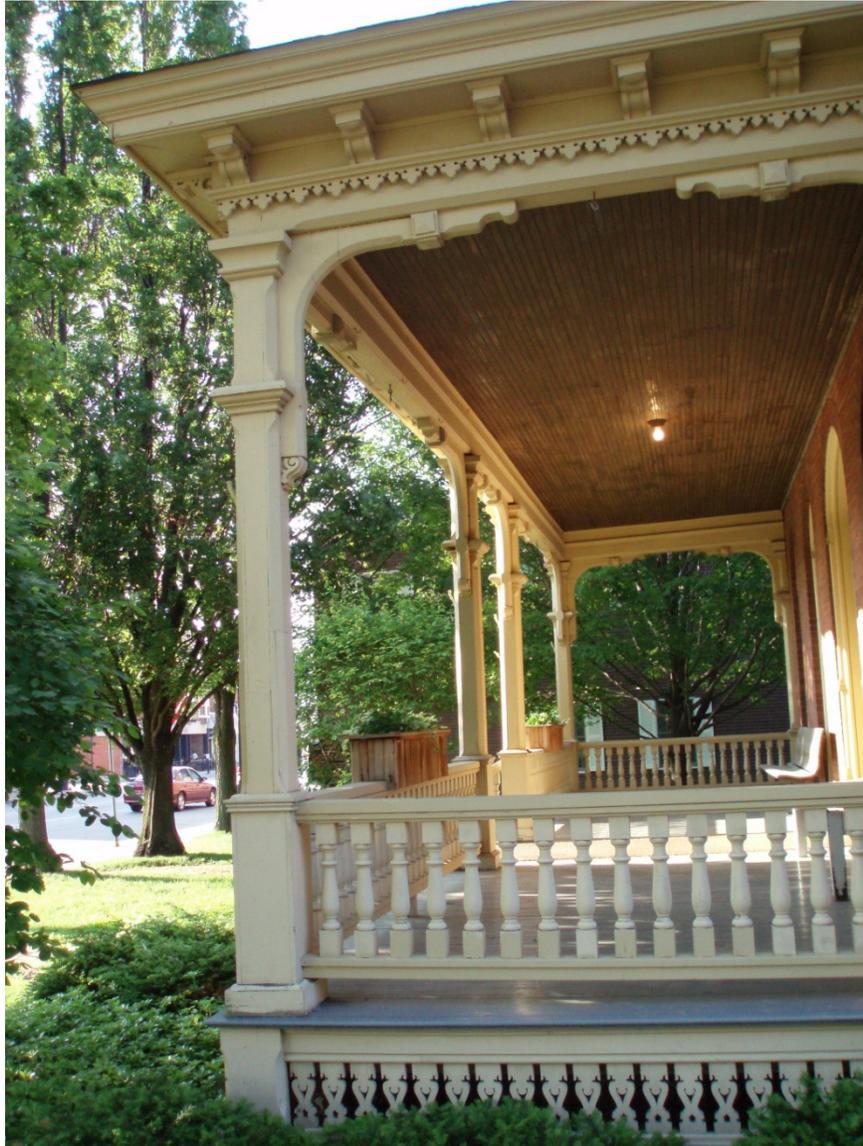
On the Cover: A Victorian-era front porch in the Village of Orchard Park, Erie County, is an excellent example of how historic features add to the character of a building and also the streetscape. Decorative elements are everywhere on the porch, from just under the porch roof to under the porch floor. Since porches are constantly exposed to the elements, they typically need constant maintenance and repair. If any of the materials here were deteriorated and needed replacement, the question then is how and with what?

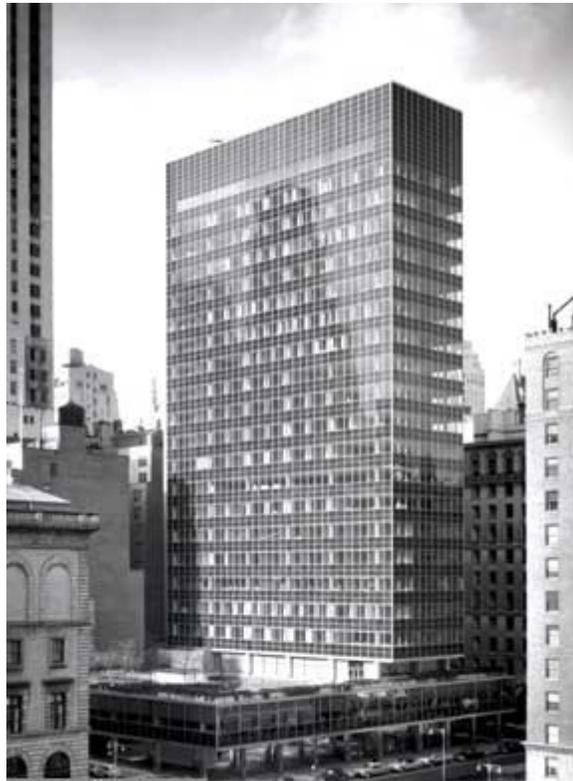
Lever House in New York City: A landmark of a modern architecture. The failure of the original sealant materials at the glass curtain walls proved that not all modern replacement materials perform as promised, and sometime must be replaced themselves.

Another, much more modern example of original materials being found inadequate for reuse was at Lever House, a National Register listed icon of modern design on Madison Avenue in New York City (1951-52). The building was radical for its time, one of the first glass “curtain-wall” skyscrapers in the United State. It rose along the traditionally stone and classically detailed Madison Avenue streetscape in the first years of the 1950s, making a bold statement about the future of architecture. Its sleek glass walls were sealed against the dirt of New York City, using “high-tech” sealants and gaskets designed to last indefinitely. Unfortunately, the technology required for the design was fairly

new and experimental, and “indefinitely” proved to be about 45 years. By 1990, the building was leaking water to the interior and heat and air conditioning to the exterior. Water infiltration was so bad that interior steel supports were rusting away and sections of the glass skin were actually falling off. During an extensive rehabilitation, the exterior materials were removed and rebuilt using systems and materials that would perform better than the original, given what has been learned about glass curtain walls since 1952. The appearance of the new exterior is extremely close to the original, but did not replicate each detail as originally built; to do so would have been inviting a new cycle of infiltration and deterioration. The main thought in any situation like this is “don’t repeat the mistakes of the past”.
